# ***Everglades Stormwater Treatment Areas: Operations and Performance Update***

**JEREMY MCBRYAN, PE, CFM**

Principal Engineer • Everglades Unit Leader  
Office of Everglades Policy and Coordination  
South Florida Water Management District

***April 7, 2016***

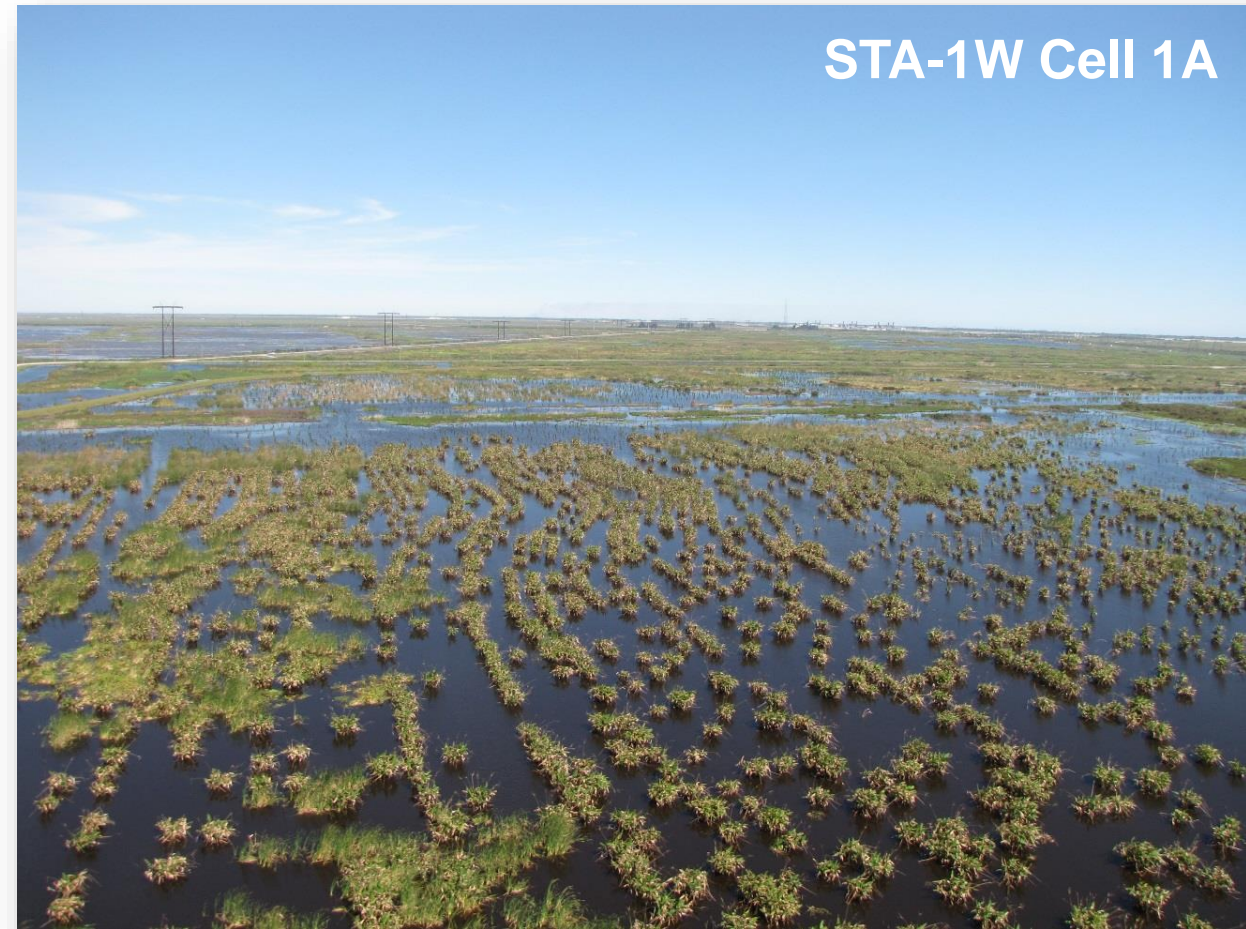
STA-1W Cell 1A

- Many STA cells have excellent EAV and SAV coverage
- In some STA cells, EAV and SAV establishment is ongoing
- SAV loss occurs during the dry season in all STAs, which can affect treatment performance
- Major vegetation management and rehabilitation activities typically occur during the dry season (Nov. – May)
- Undesirable vegetation is controlled throughout the year
